TECHNICAL REPORT ARCCB-TR-92033

**FAILURE ANALYSES OF
M3A1 BASEPLATE FOR 81-MM MORTAR 252**

STEVE TAUSCHER

JULY 1992

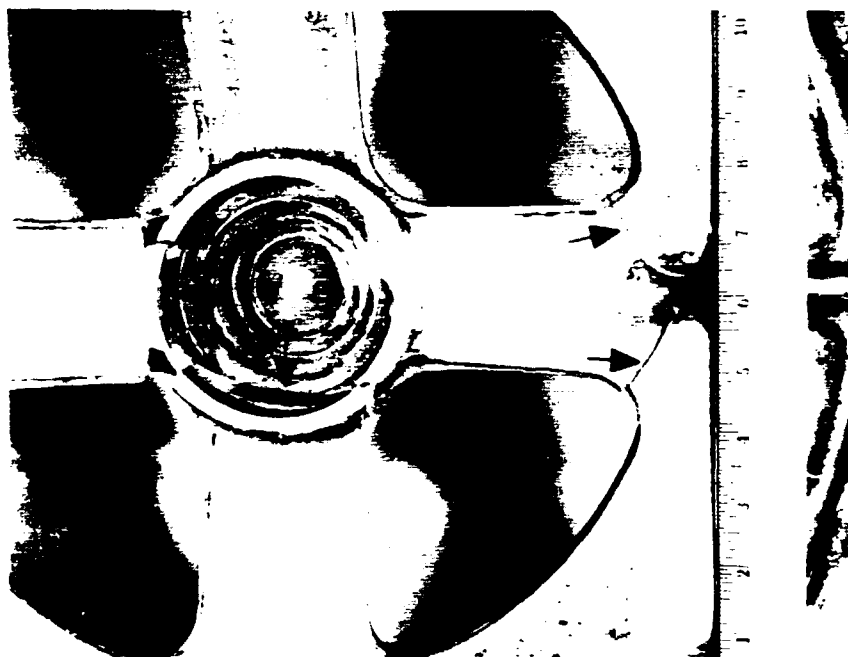
A visual examination of the baseplate (Figures 1 through 4) and of the fracture surfaces was conducted to identify any material and/or forging defects as well as to characterize the type of failure, i.e., fatigue, ductile, brittle, etc. An examination was also conducted to determine the origin of failure, if possible. Three fracture surfaces were created during the failure; two on the spades (Figures 2 and 3), one-third of the way from the hub to the outer ring, and one between the fillets of two adjacent triangularly-shaped holes (Figures 2 and 4). These locations have been previously identified as the areas of highest stress (ref 1), and have been the locations of cracking initiation in previous baseplate failures (ref 2), as well as fatigue-tested baseplates (ref 3).

Figure 2. Closer view of same baseplate.

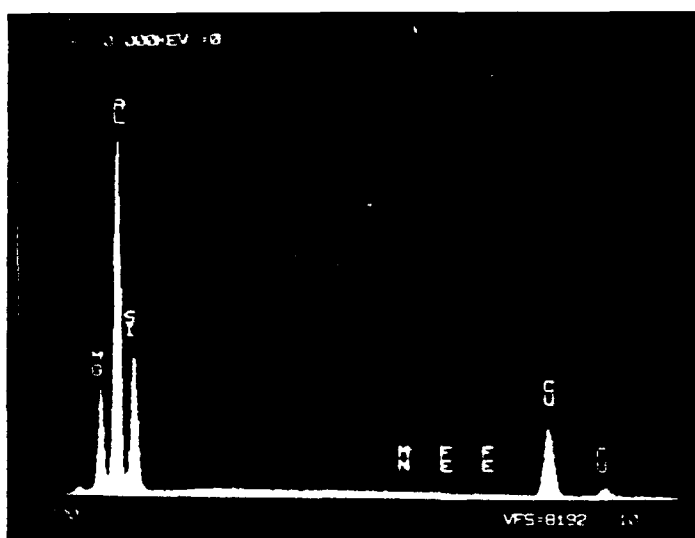
EDS was utilized to identify the composition of the particles shown in Figure 11. Figures 14 through 18 illustrate the elements found in particles on the polished and etched surface of a metallographic specimen. This analysis of elements, coupled with the gray levels revealed by Keller's reagent in optical microscopy, identified the larger particle constituents as CuAl_2 , $(\text{FeMn})_3\text{SiAl}_{12}$, and $\text{Cu}_2\text{Mg}_8\text{Si}_6\text{Al}_5$.

Figure 18. EDS analysis of small gray microstructural constituent shown in Figure 16.
